MILL RIVER BASIN  
FAIRFIELD, CONNECTICUT

**SAMP MORTAR RESERVOIR DAM  
CT 00017**

**PHASE I INSPECTION REPORT  
NATIONAL DAM INSPECTION PROGRAM**

MAY 1979

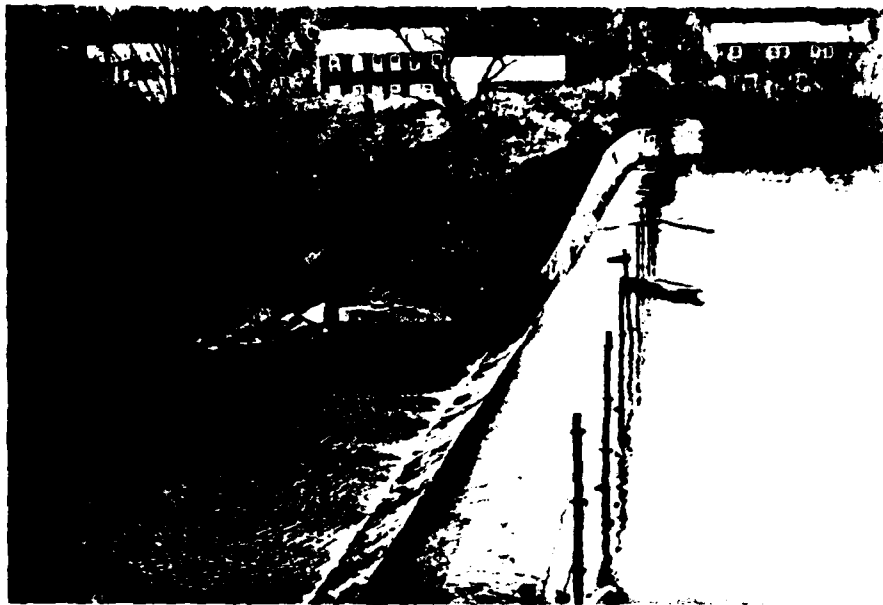
PHOTO NO. 1 - Looking right (west) across  
spillway from gatehouse.

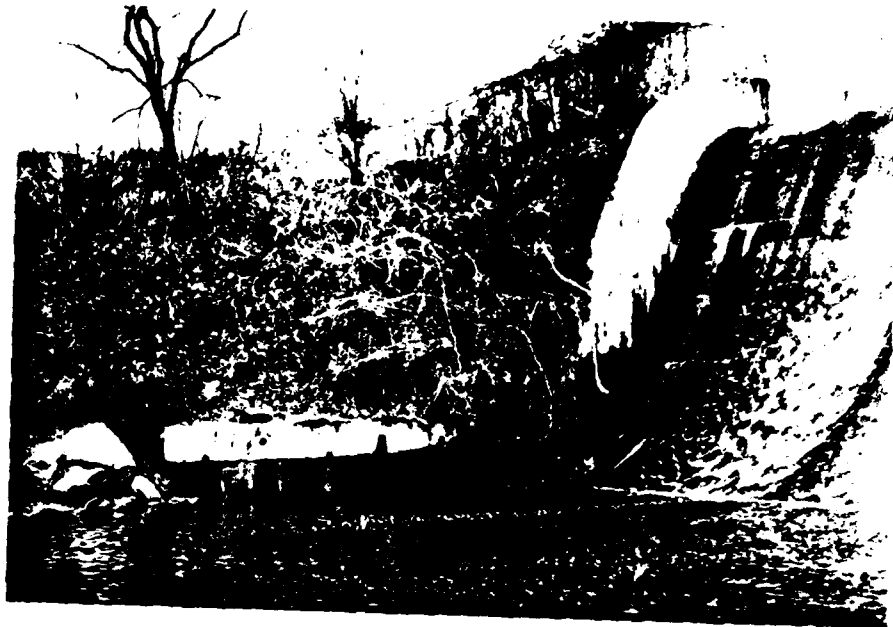
A seepage zone was observed in the right abutment about 25 feet downstream of the right training wall (Photo 13). The area had a rust colored appearance. As shown in Photos 9 and 15, seepage is occurring through the right training wall at an apparent construction joint.

c. Appurtenant Structures. Visual inspection of the concrete spillway, spillway channel and outlet works did not reveal any evidence of stability problems. The spillway section was under water and could not be observed. The concrete surface of the spillway training walls is cracked and showed some staining and florescence. The horizontal section of the right training wall has been capped with concrete to a height of approximately 18 inches as seen in Photo 9.

PHOTO NO. 9 - Downstream of spillway weir  
looking at right (west) abutment.

a. A program for monitoring of the seepage observed along the left and right abutments of the dam should be implemented. Monitoring should be visual to evaluate the turbidity of the water and also photographic evidence would provide a record to suggest whether there are substantial changes in the volume or in the size of the wet areas from one inspection to another. Presence of suspended solids in the water or substantial changes in flow not related to changes in reservoir level should be considered as indications of a critical condition.

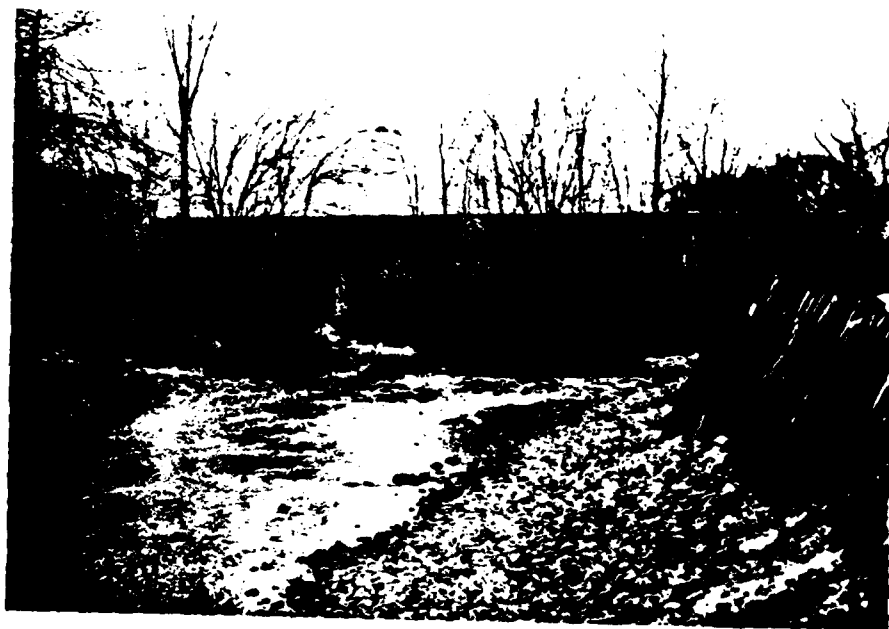
The visual inspection of Samp Mortar Reservoir Dam indicated that the dam is in fair condition. The inspection revealed some soil erosion on both abutments as seen in Photos 2, 3, 4 and 14. Trees are growing from both abutments as seen in Photos 1, 2, 3 and 5. Several seepage zones were observed on both abutments as can be seen in Photos 6, 9, 13 and 15. Water from 24 and 30 inch pipes along the toe of the left abutment has eroded the left abutment as shown in Photo 8. Also, there are numerous trees in the downstream spillway channel as seen in Photos 10 and 12.

PHOTO NO. 10 - Downstream of dam looking  
up spillway channel

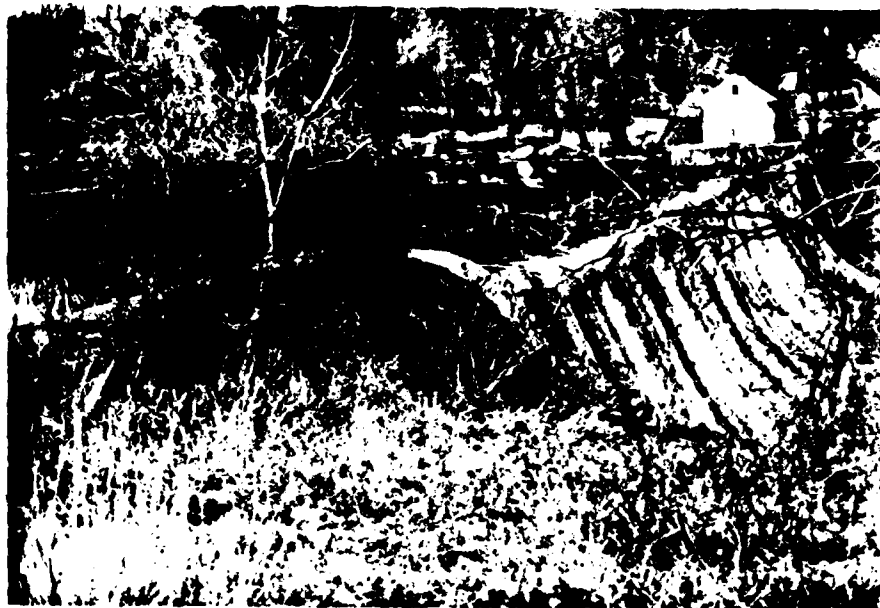
PHOTO NO. 11 - Looking toward spillway structure  
from right (west) abutment.
